BC's Magazine for Trenchless Construction

DiG2

Official Publication of the North American Society for Trenchless Technology • British Columbia Chapter WWW.NASTE-DC.OFG

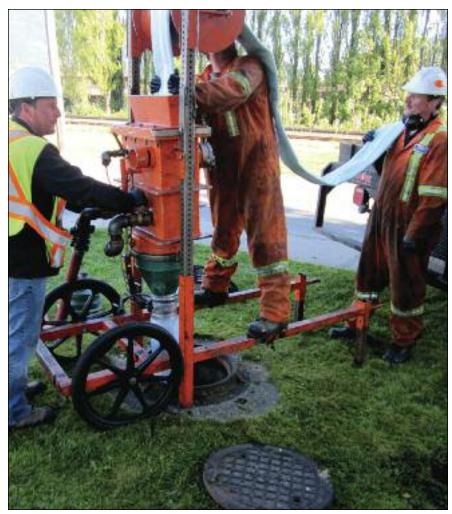
Mar-Tech installs liner before curing.

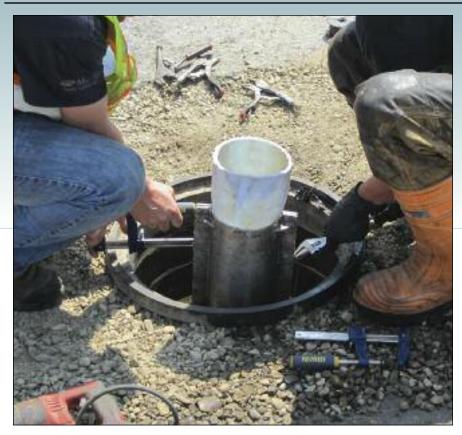
An inversion sample is taken for testing.

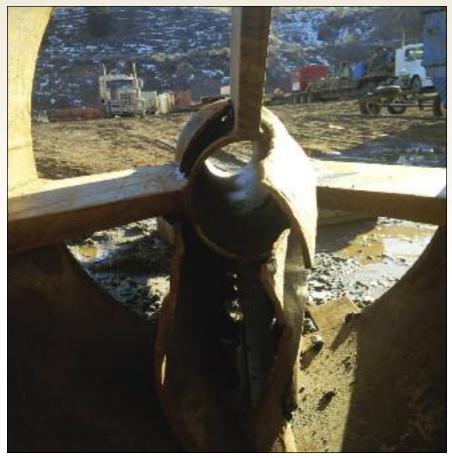
A project in Maple Ridge required a specially designed burst head.

the casing through the existing PVC. To do this we designed an eccentric burst head to be welded to the lead pipe of the 30-inch casing. Since the invert elevations were critical, we had to fabricate the burst head so that the new 475-mm PVC would match the existing 250-mm. To control the alignment and grade, we proposed to use nominal eight-inch SCH40 pipe. This pipe would be pushed through the existing PVC/ductile sanitary line. Custom fins were cut out of 1.5 inches mild steel plate and arranged at the 12, 3, 6 and 9 o'clock positions. The height of each fin created an axis that would not be centrally located. This arrangement would hopefully solve the problem of achieving the design invert elevations of the proposed new sanitary.

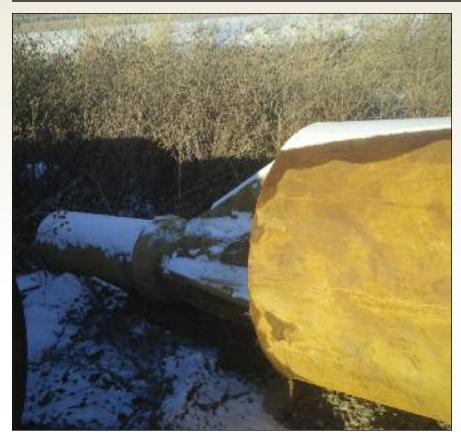
KAB designed an eccentric burst head for the Maple Ridge project.

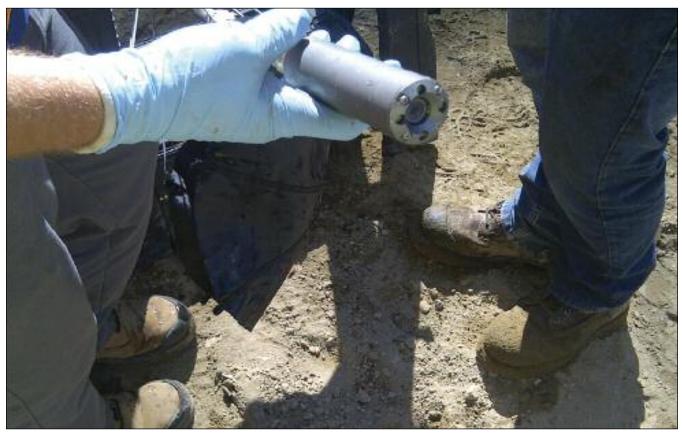
The LDS1000 system, which includes a camera and microphone, was used to inspect a watermain in Whistler.

ost pressurized pipeline inspection allows you to listen as the tool advances into the pipe. The new JD7 LDS1000[™] process used by GAME Trenchless Consultants^{*} allows for a visual and acoustic inspection of watermains in live systems, while users still have domestic water and fire protection supply. The acoustic capability of the camera head works on the premise that under a pressurized environment, a leak (big or small) will create a sound. The sensitivity of the microphone can pick up the sound and the sound increases as the microphone nears the source and decreases as it moves

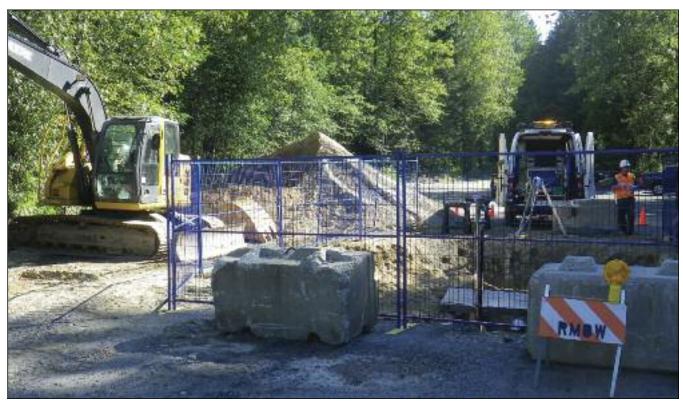
The Whistler watermain condition assessment was conducted in July 2013.

In July 2013 GENIVAR was contracted by Royal Building Products to provide a visual condition assessment and leak detection of a 350-mm (14-inch) watermain having a length of approximately 520 meters (1,700 feet) in the Resort Municipality of Whistler (RMOW). The LDS1000 technology was chosen because the inspection could be performed while the watermain was still live and because the LDS1000 device required only a small tap of 50 mm (two inches) on the main line for access. The tap was installed in an adjacent section of the watermain, not directly under a secondary roadway. Following the inspection, the RMOW still required a final leakage test prior to accepting the original installation.

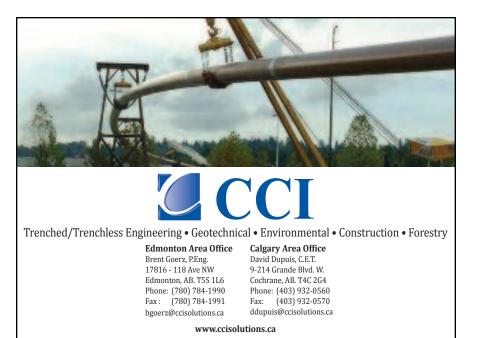
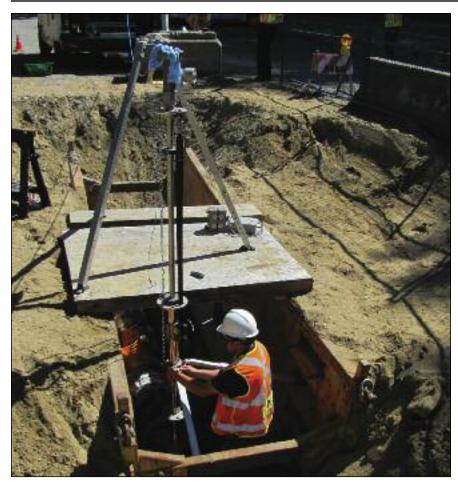
Water service continued as inspection of the main was conducted.

flow of approximately 0.3m/s is required to make the tool advance in the watermain. RMOW was able to create a flow of approximately 0.6m/s. During the entire operation, the cable being fed into the watermain was constantly chlorinated.

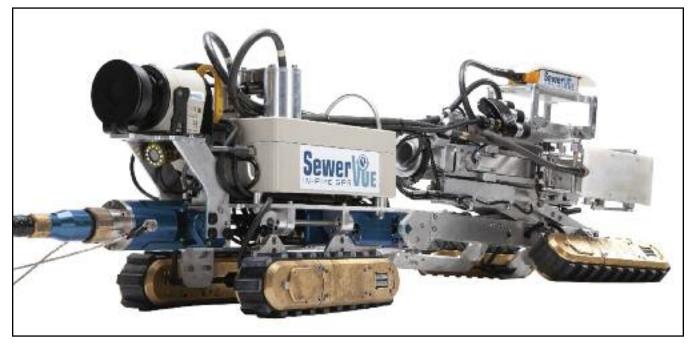
The SewerVUE Surveyor is a multi-sensor robot that utilizes CCTV, LiDAR and PPR.

The SewerVUE Surveyor is the first commercially available multi-sensor inspection robot that uses visual and quantitative technologies (CCTV, LiDAR, PPR) to inspect underground pipes. This fourth-generation PPR pipe inspection system is mounted on a

rubber-tracked robot and equipped with two high-frequency PPR antennae. Radar data collection is obtained via two independent channels in both in and out directions, providing a continuous reading on pipe wall thickness, rebar cover and voids outside the pipe. CCTV data is recorded simultaneously and used for correlation with PPR data.

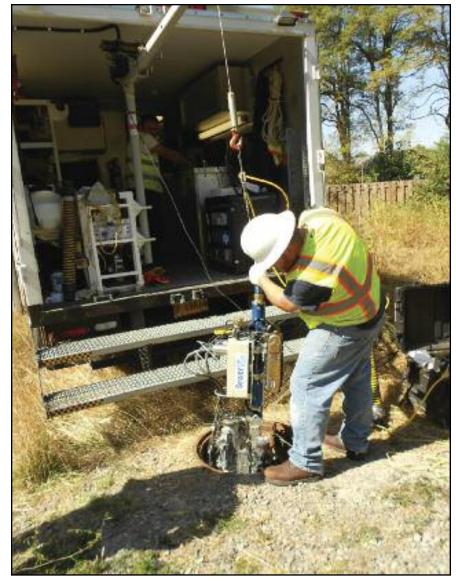
The SewerVUE Surveyor robot is deployed at St. Johns manhole 28-377.

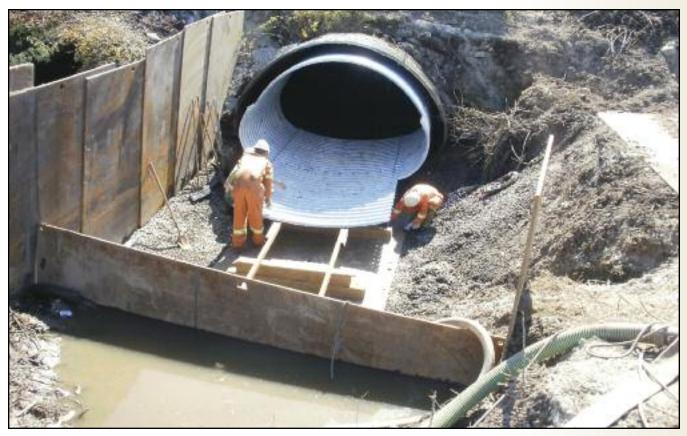
A Bolt-A-Plate structure system was used to slipline a culvert under a BC Rail track.

A 3100 mm x 1980 mm Atlantic Industries Ltd. 15PA10-9 Bolt-A-Plate structure pipe arch was proposed as a stand-

alone structural liner for the installation. This product satisfied the 75-year design-life requirement. The pipe arch at a thickness of 4.0 mm was designed to withstand the loading of the existing cover of approximately three metres as well as the loading caused by the train traffic.

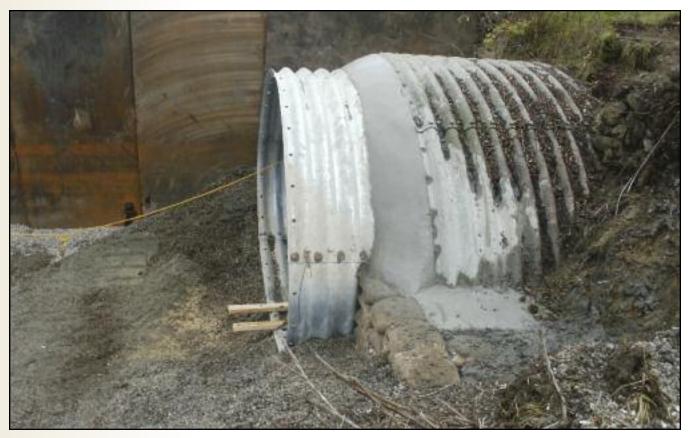
A dry working environment was required for the culvert rehabilitation project.

year for this type of work would be limited to the dry months of summer. In order to perform the work, a dry working environment would need to be maintained. PW Trenchless installed a steel plate weir system to provide a dry coffered dam area on the inlet and outlet ends of the existing culvert. The inlet and outlet access points were excavated of all organics and sediment and then lined with drain rock for ease of culvert liner constructability.
